Debris/Ice/TPS Assessment and Integrated Photographic Analysis of Shuttle Mission STS-75

Technical Memorandum 111472

April 1996

22 February 1996

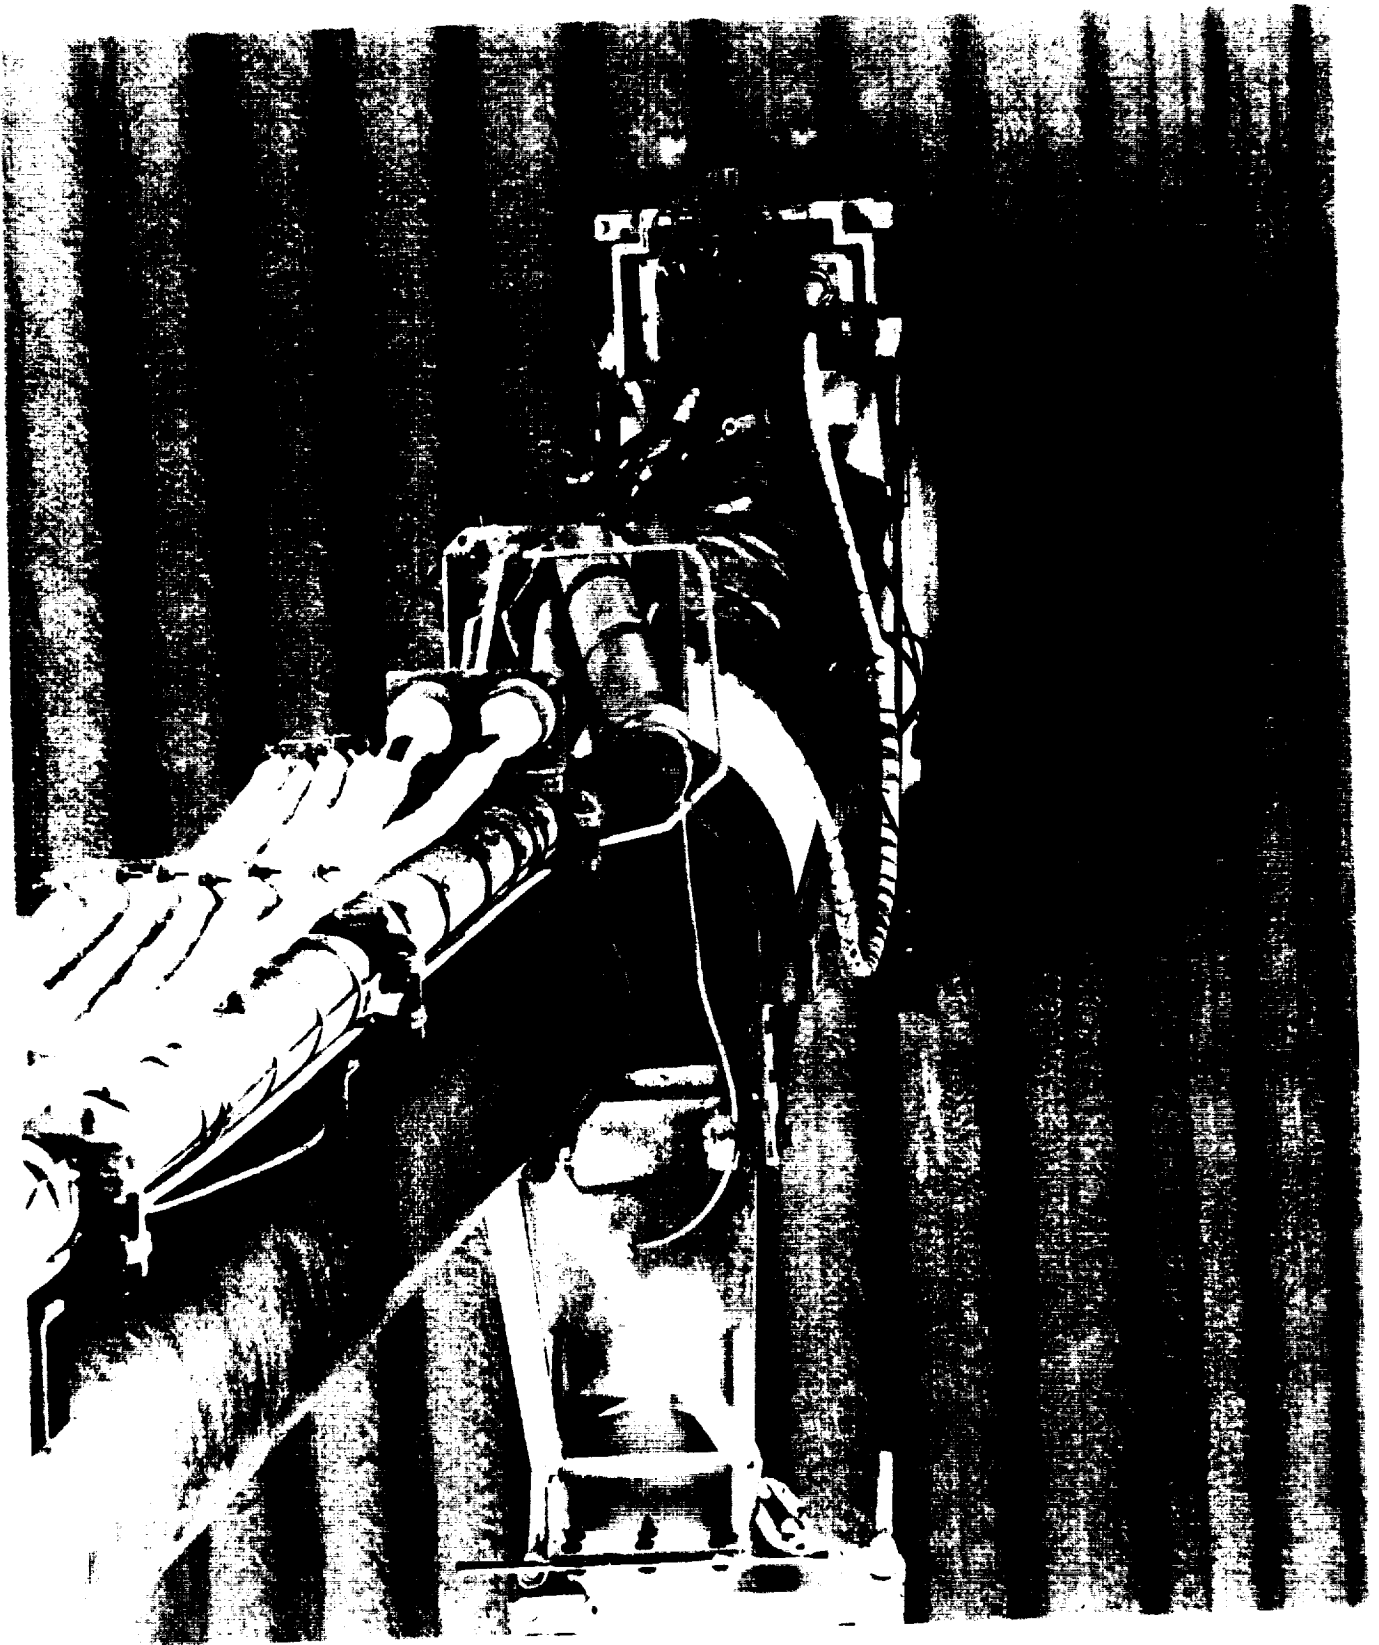
Photo 5: Sodium Hydroxide Residue on GUCP

The GH2 vent line had no loose cables, and appeared to have latched properly with no rebound. The GUCP legs and crossbeam showed no obvious signs of contact by the static retract lanyard. The vent line was latched on the eighth tooth of the latching mechanism. The RSS cable had disconnected properly. One latch back retainer spring was broken. The GUCP frame and legs were etched/discolored from the caustic sodium hydroxide leak of 21 February 1996.

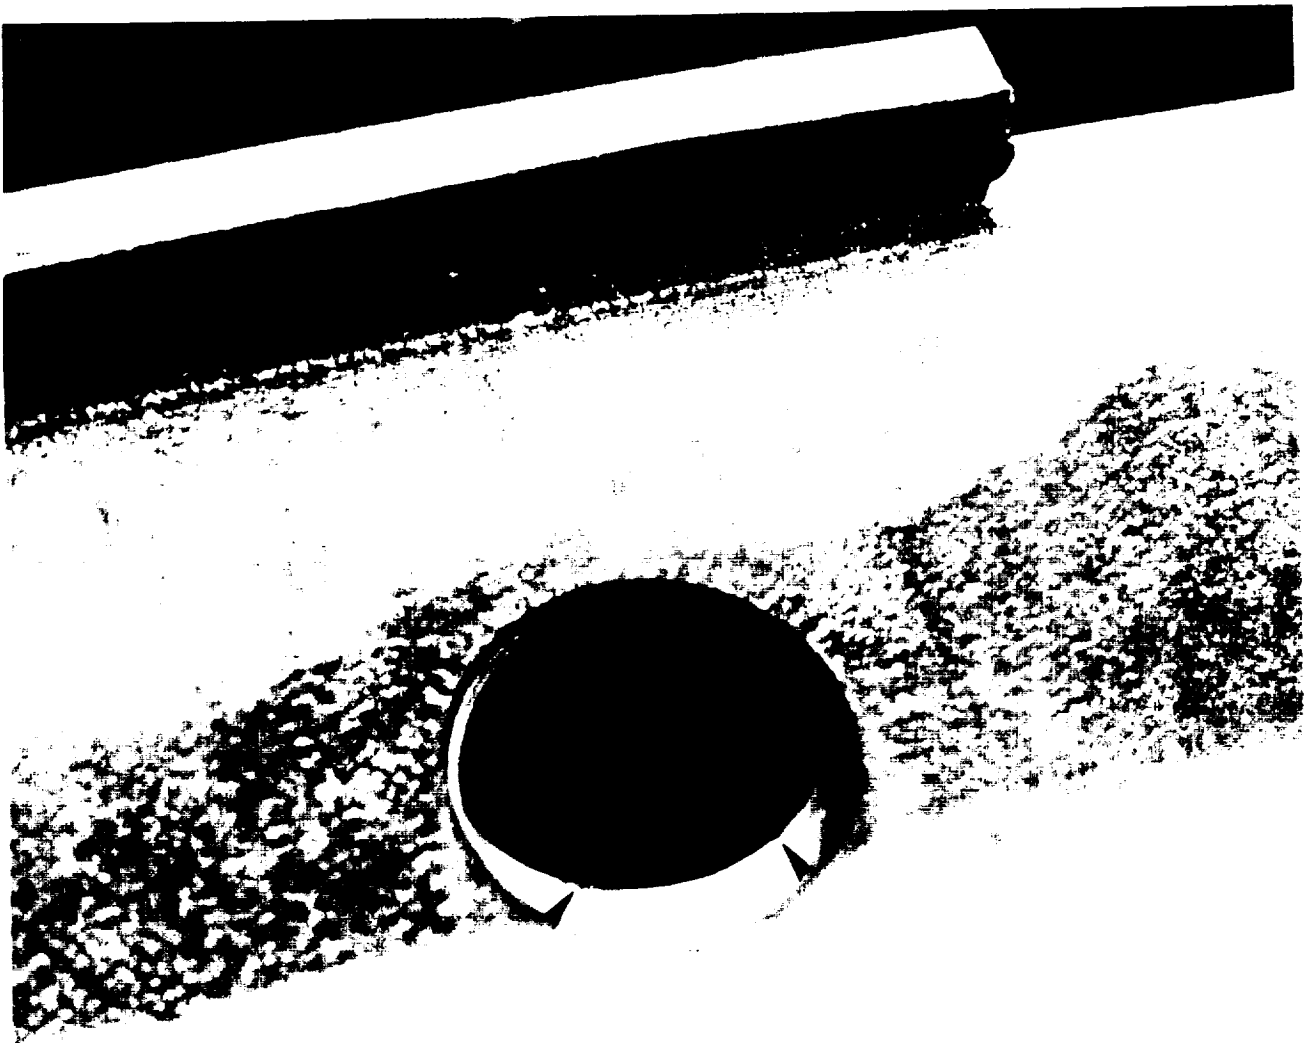
Photo 7: HDP #5 Stud Hang-Up

HDP #5 stud hole exhibited burrs around the +Z edge, a visual indication of a stud hang-up

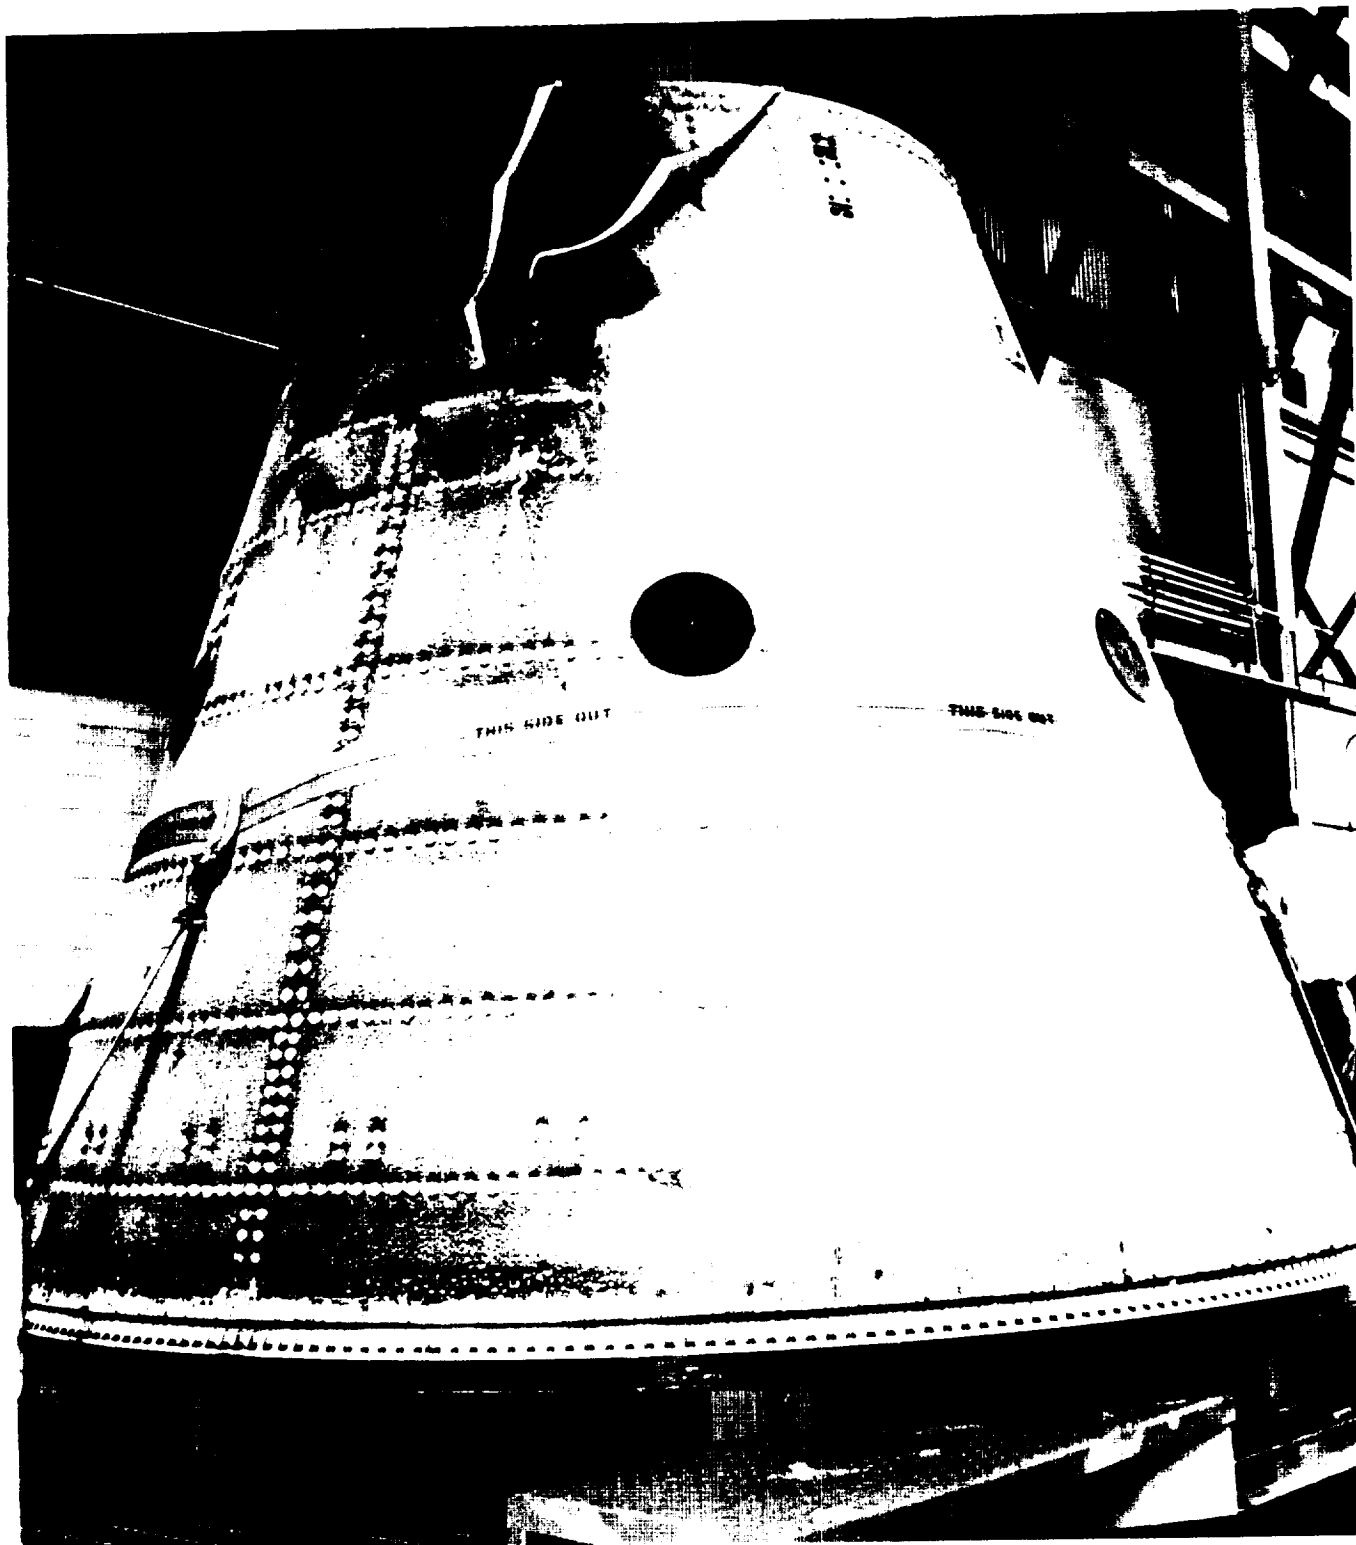
Photo 14: RH Frustum

The RH frustum was missing no TPS. The number of debonds over fasteners (16) and over acreage (2) was less than average. Hypalon paint was blistered/missing along the XB-395 ring frame where BTA closeouts had been applied. However, most of the exposed BTA substrate was not sooted. The BSM aero heat shield covers had locked in the fully opened position.

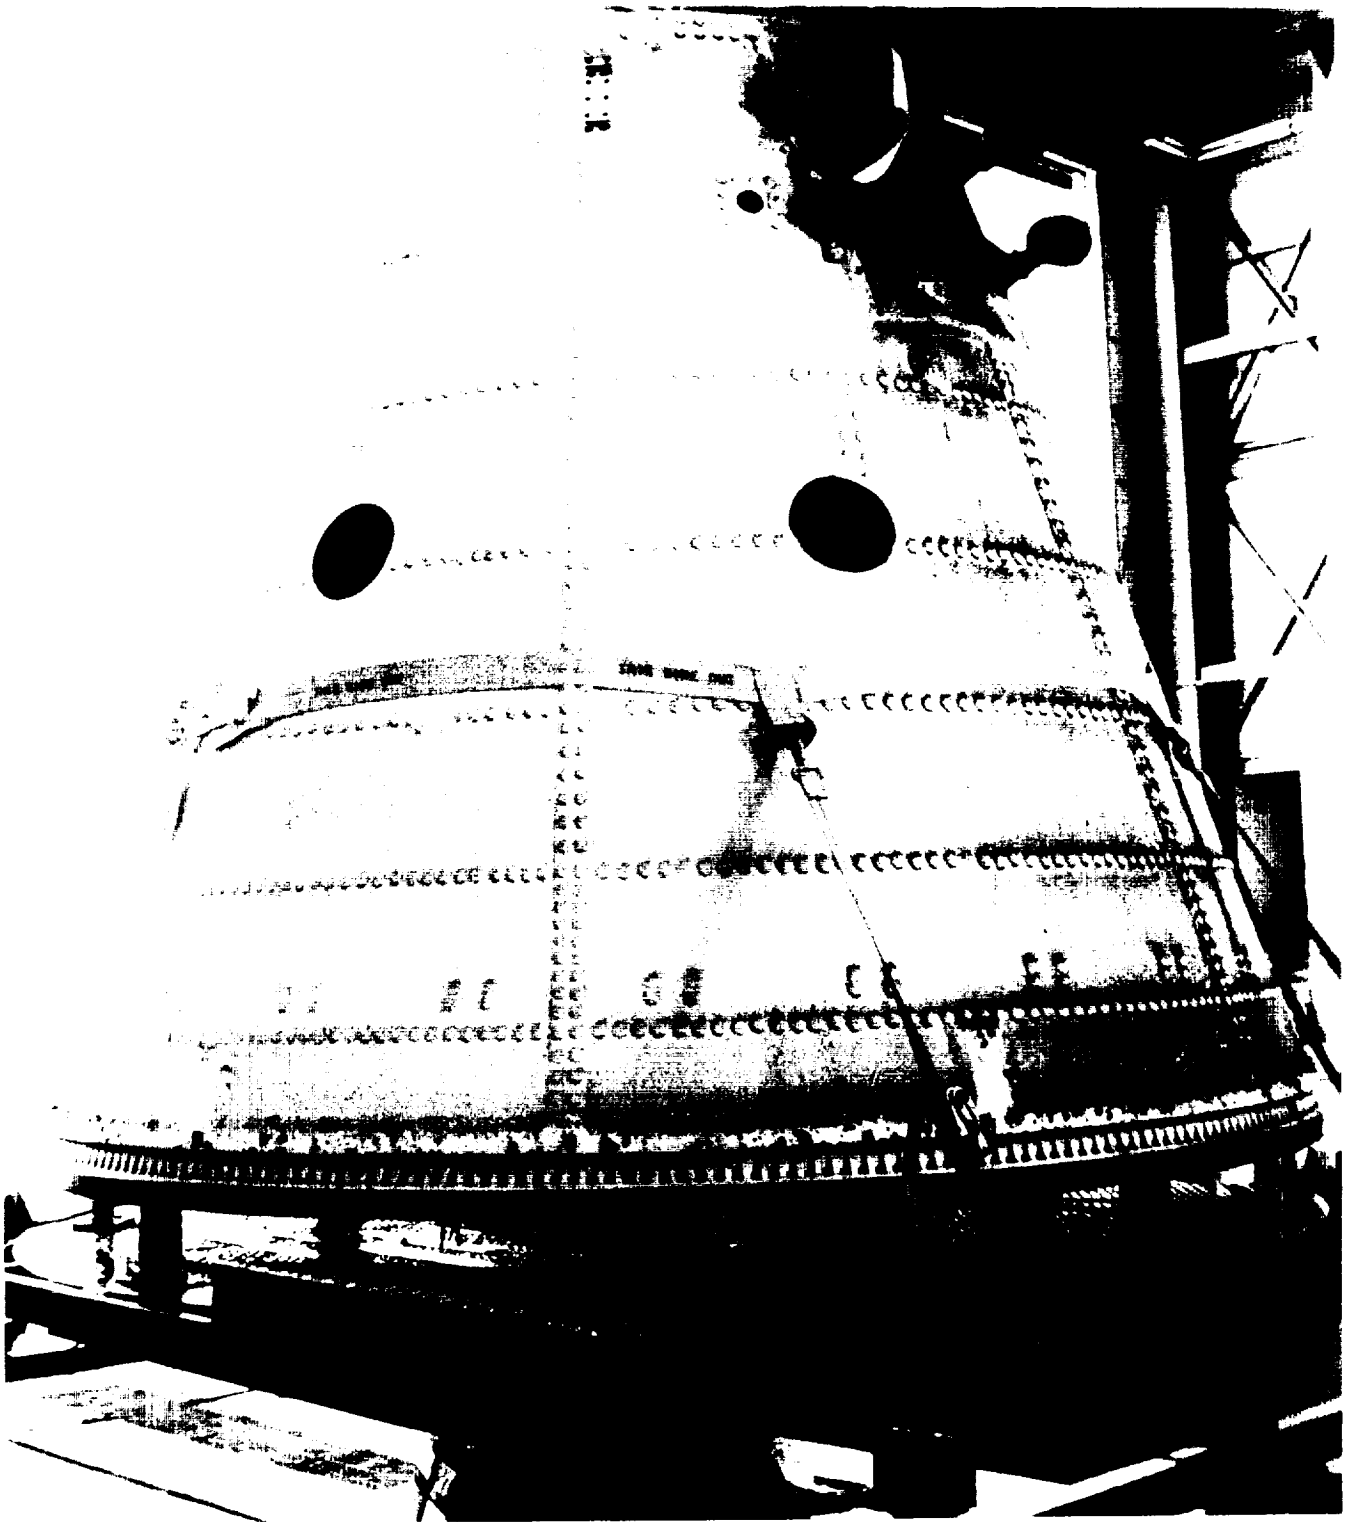
Photo 17: LH Frustum

The LH frustum was missing no TPS. The number of MSA-2 debonds over fasteners (20) was less than average. The BSM aero heat shield covers had locked in the fully opened position though the two right cover attach rings had been bent by parachute riser entanglement after splashdown.

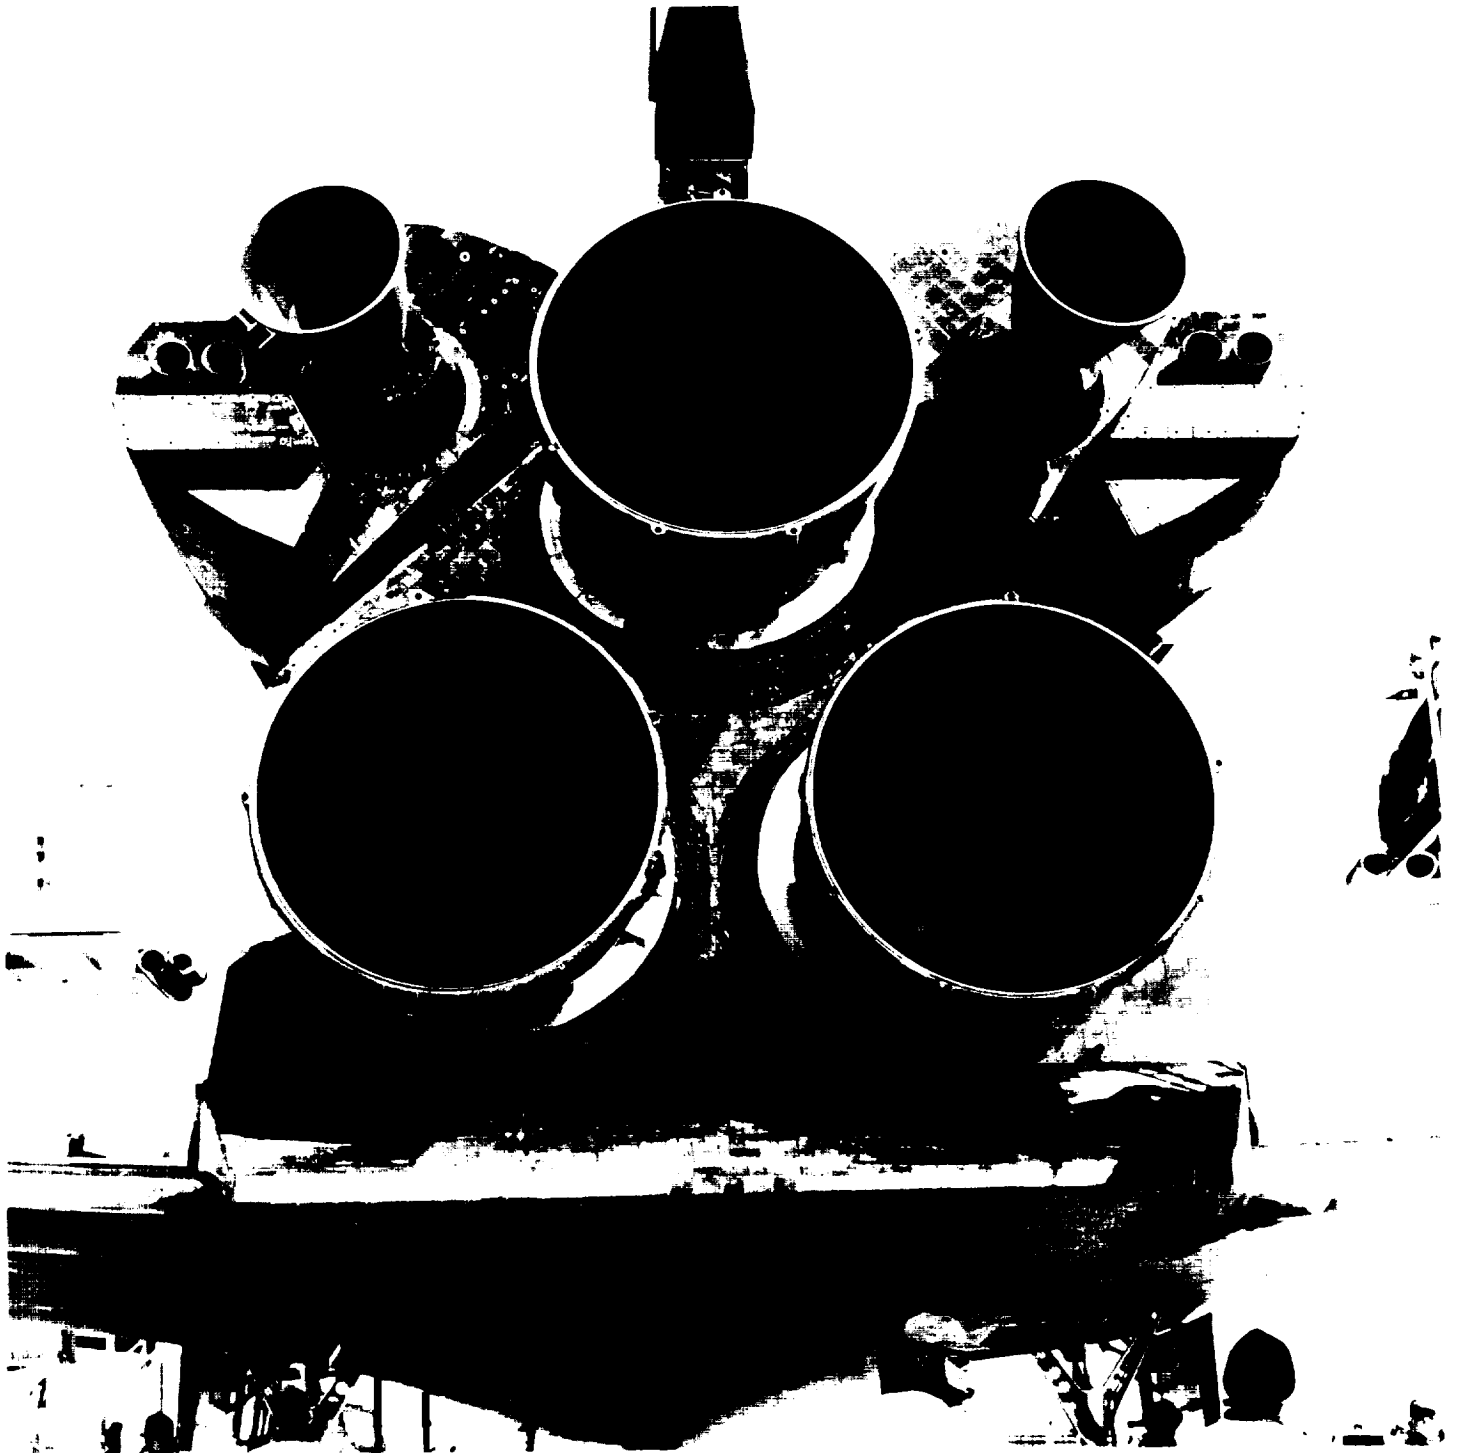
Photo 23: Base Heat Shield/SSME's

The SSME #1 and #2 Dome Mounted Heat Shield (DMHS) closeout blankets were unstitched or torn at the 6-7:00 o'clock and 3-5:00 o'clock locations, respectively. The SSME #3 DMHS was in excellent condition with no damaged material. Tiles on the vertical stabilizer "stinger" and around the drag chute door were intact and undamaged.

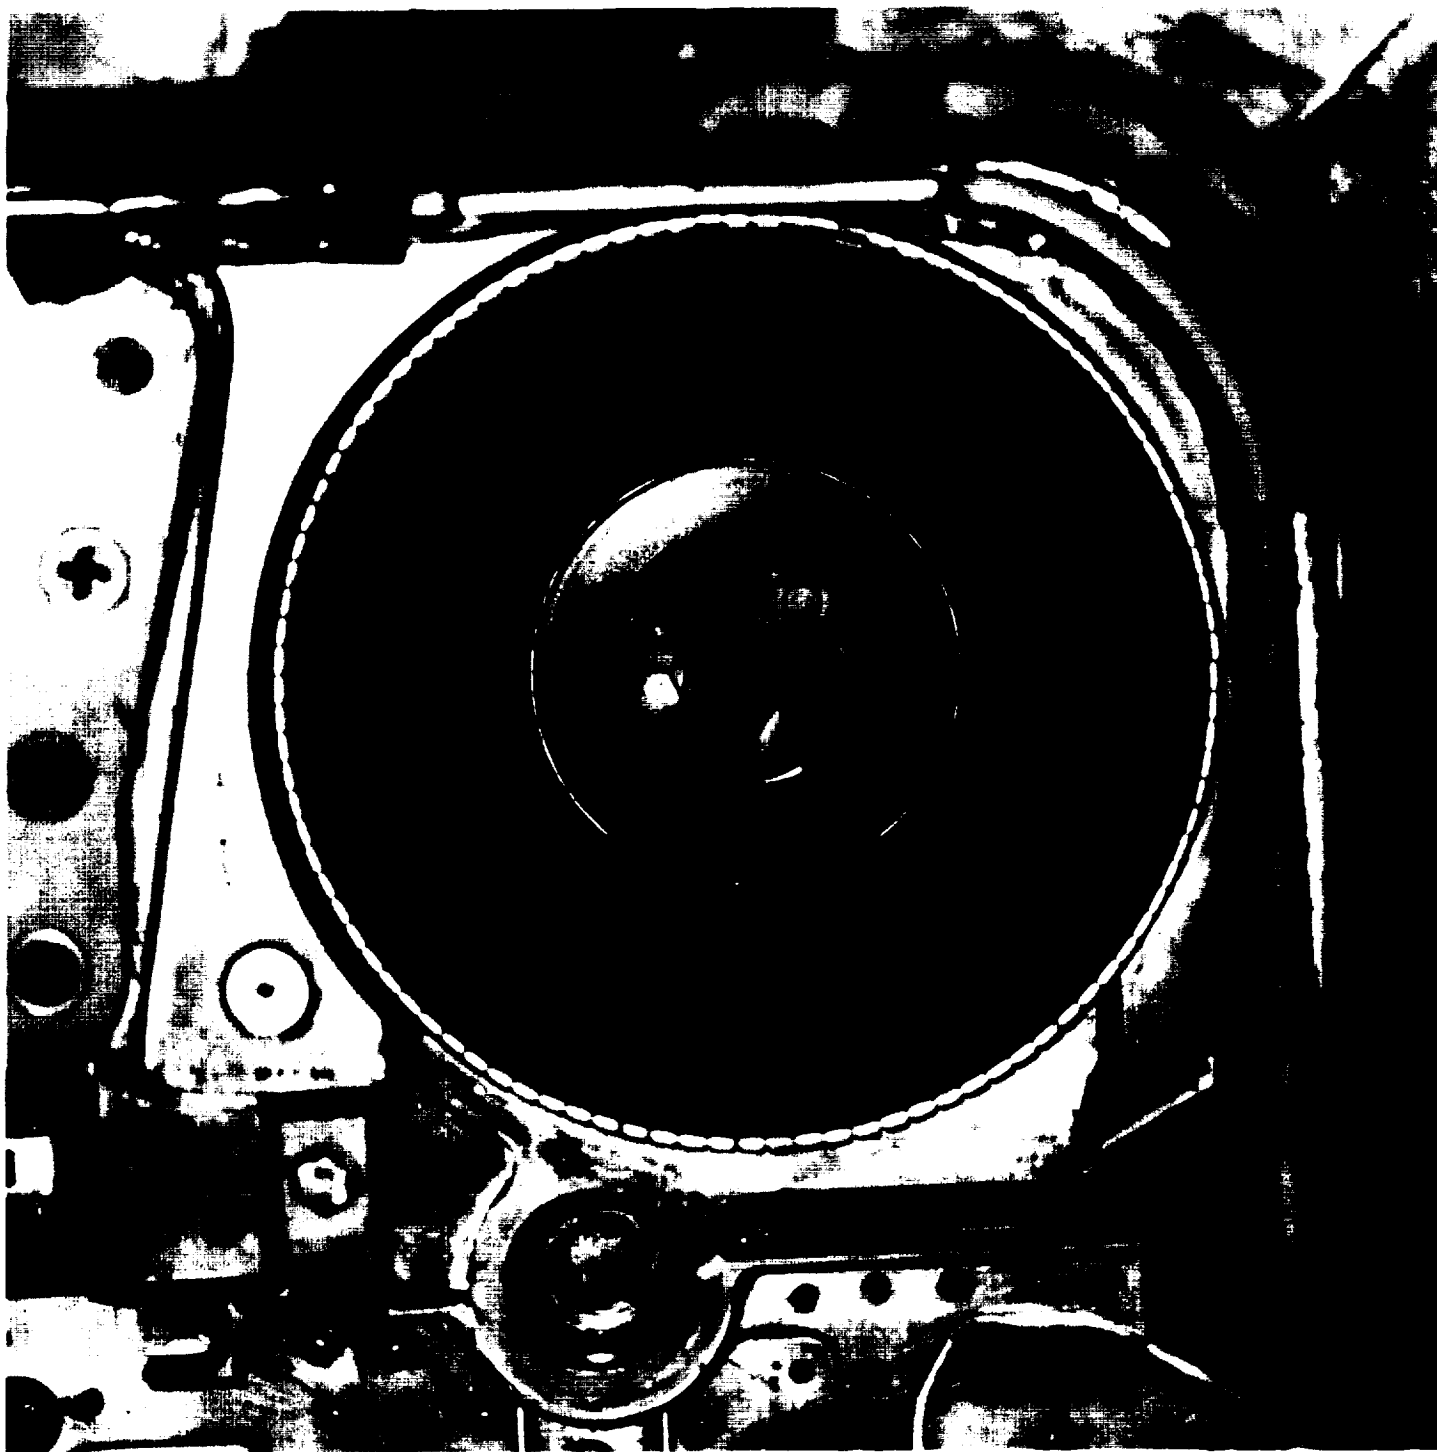
Photo 26: EO-2 Debris Container Iris

ET/Orbiter separation devices EO-1 and EO-3 functioned normally. The EO-2 debris container iris was obstructed and had not closed fully. No ordnance fragments were found on the runway beneath the umbilical cavities.

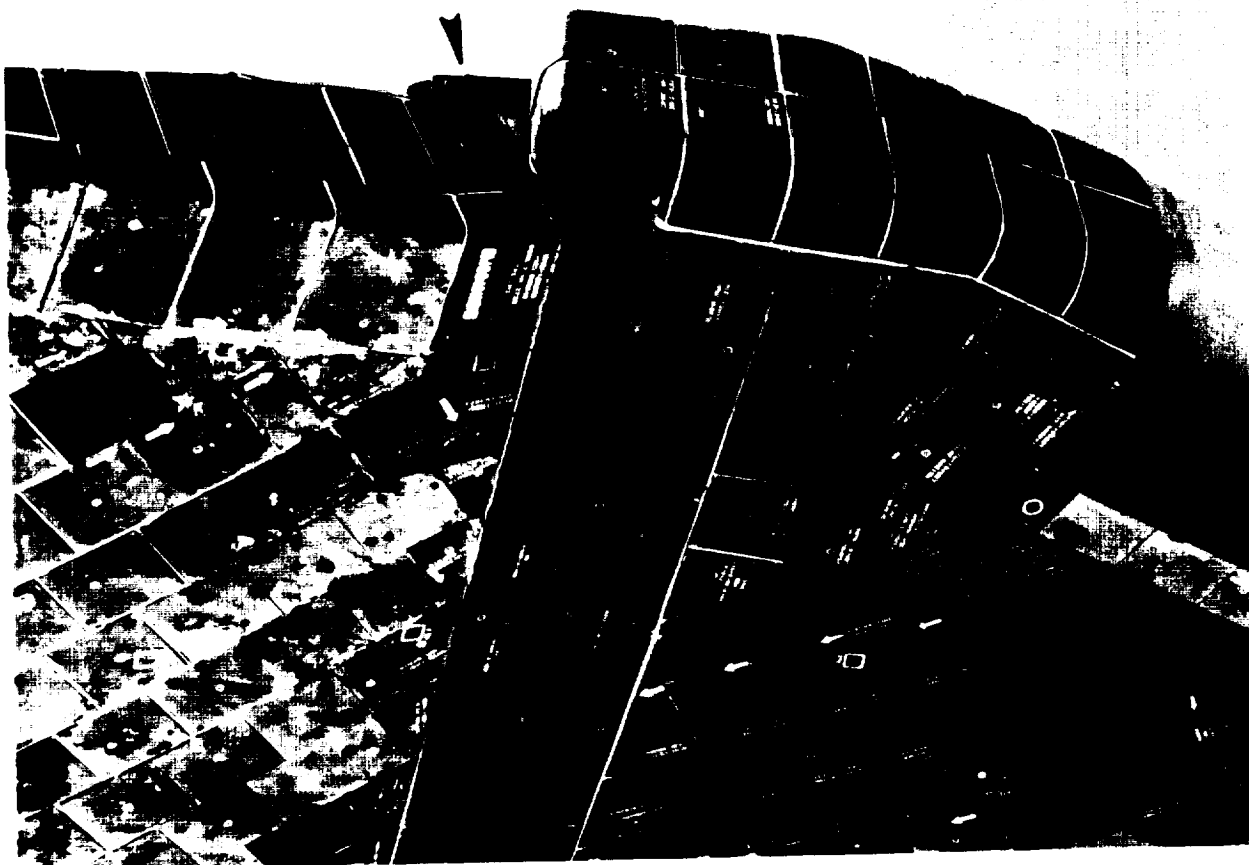
Photo 28: Flipper Door #15

Right outboard flipper door #15 was dislocated from the rail

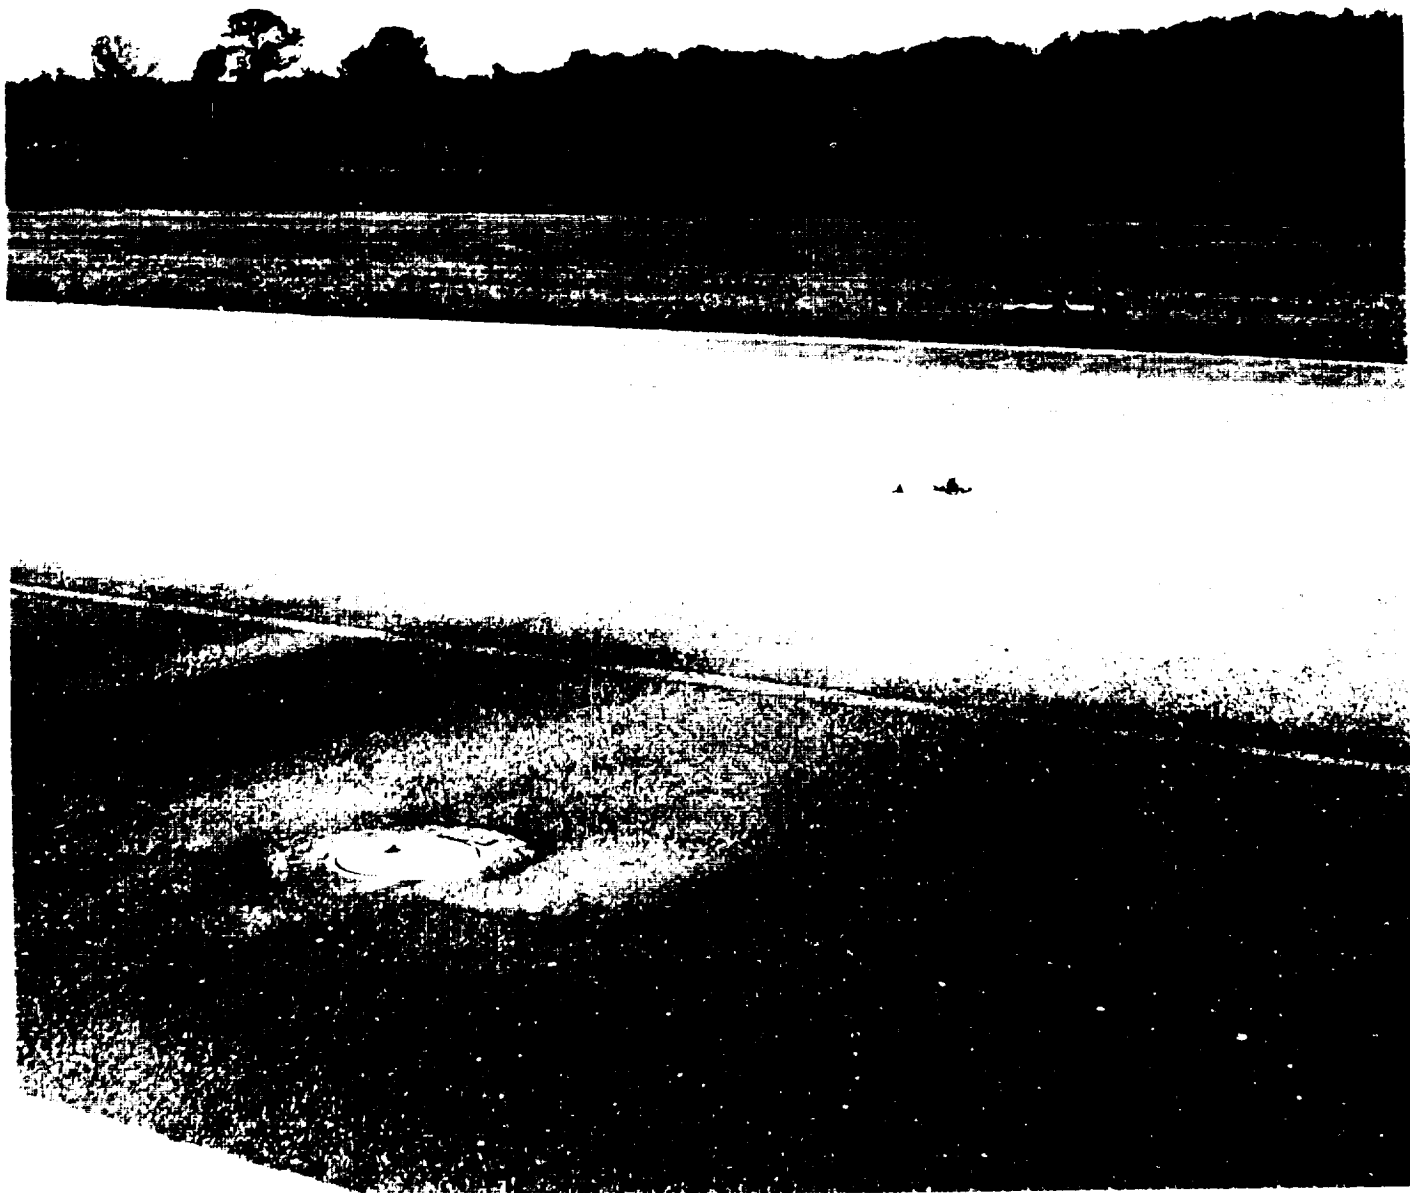
Photo 31: Runway Light Damage

All drag chute hardware was recovered and appeared to have functioned normally. The drag chute door had skidded along the runway and impacted a runway perimeter light. The major pieces of the light stanchion and lens were recovered.
